PRINCETON UNIV N J DEPT OF ELECTRICAL ENGINEERING
THE INFLUENCE OF CONTACT AND INTERFACE EFFECTS OF THE ELECTRONI--ETC(U)
JUL 79 P MARK

FINAL TECHNICAL REPORT:

The Influence of Contact and Interface Effects
of the Electronic Properties and Stability
of Chemically Unstable Materials

SCANNING AUGER MICROSCOPY (SAM) STUDIES OF WORN BORE SURFACES*

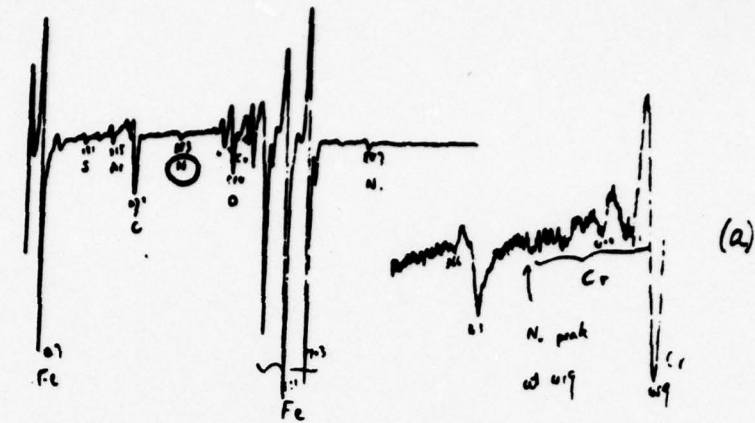
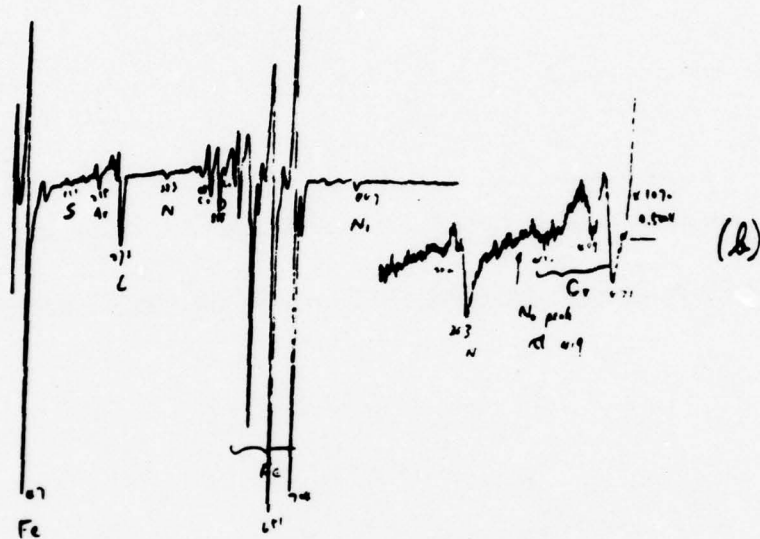
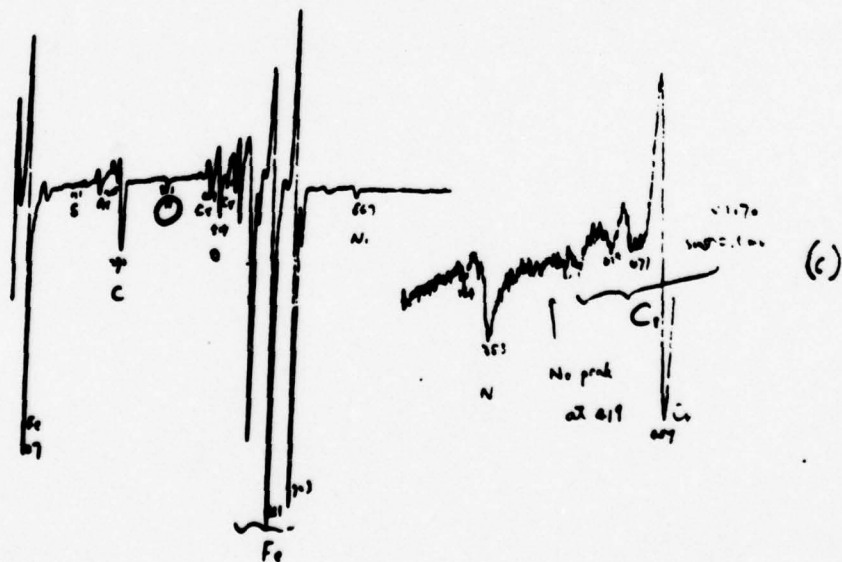
Figure 5

Although there are clear differences in the elemental distributions in these cracks, there are also some common features. For example, the C-images all show that carbon is distributed along the entire length of each crack. The C-signals of AES traces of Fig. 5 are clearly carbide signatures indicating that the carbon in the cracks are most likely metal carbides that have segregated there during the embrittlement of the steel. On the other hand, the N-images all show nitrogen distributions that tend to aggregate at the middle of each crack. The nitrogen is probably in the form of metal nitrides which were formed by reactions between the metal on the crack surfaces and the nitrogenous constituents of the hot propellant gases under pressure during the firings. The absence of nitrogen at the open end of the cracks can be attributed to competing reactions with oxygen to form volatile components. This is suggested by the fact that the O-images show the oxygen more or less concentrated at the open ends of the cracks, in part bonded to carbon (because of the partial correlation with the C-images) and in part as iron oxides because of the correlation with the iron images. No Ti was detected in the cracks. At this point in our work it is not clear why. It may have to do with the fact that the cracks were not clearly correlated with the austenitic grain boundaries of the pebbled surface.

Pebbled Surface: AES traces from surface cracks
sputter-cleaned surface
(a)-point A (b)-point B (c)-point C

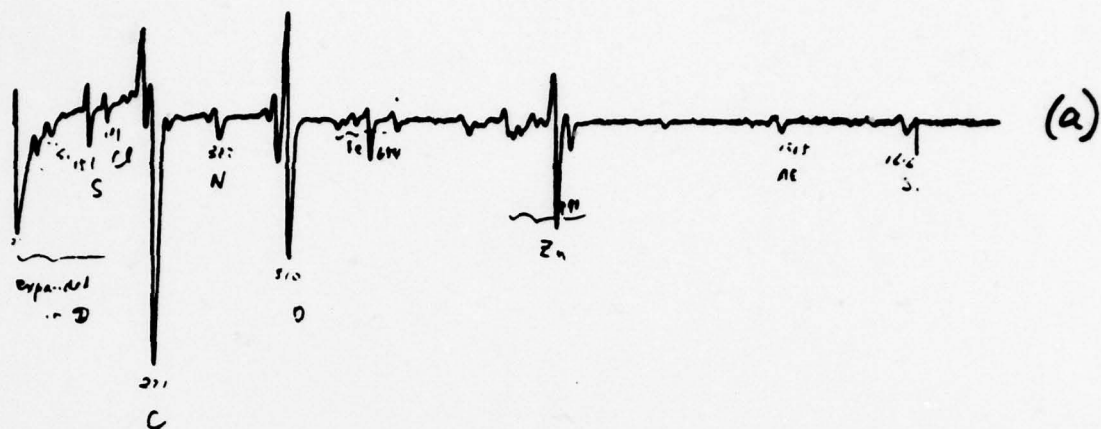
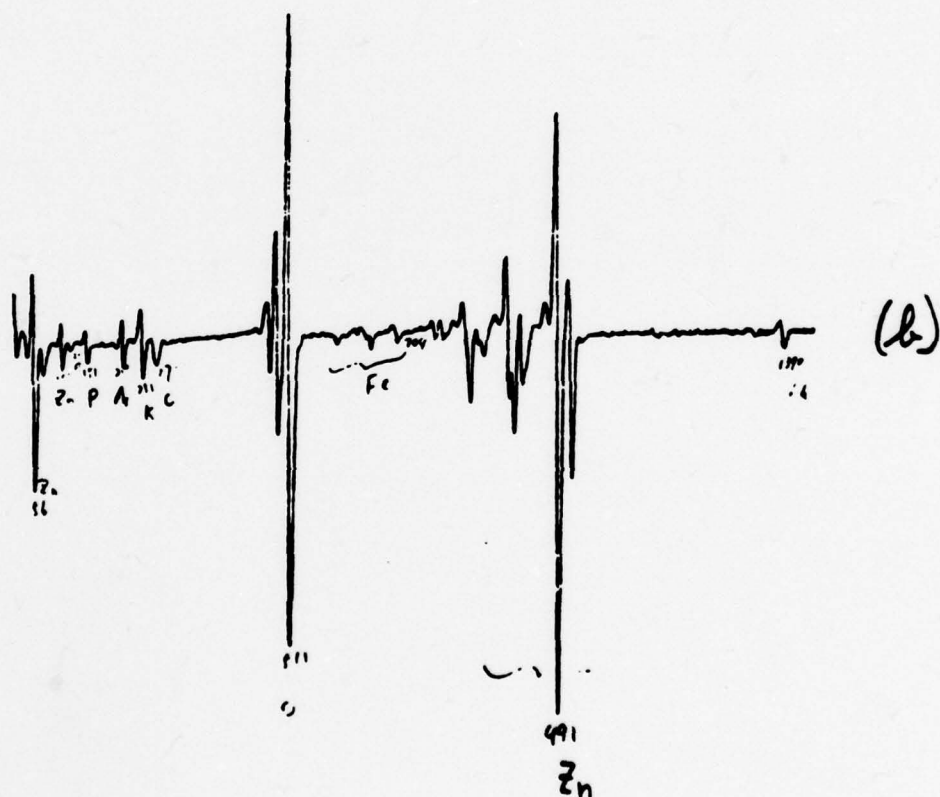
Figure 9

A section from a Cr-coated 105 mm M-68 barrel was also subjected to normal incidence SEM/SAM analysis. A low magnification SEM secondary emission image is shown in the photograph of Fig. 10, panel a. The AES trace from point B of the virgin surface is shown by trace a of Fig. 9. The AES trace of the sputter-cleaned surface is shown by trace b. Trace a shows the typical strong C- and O-signals of environmentally contaminated surfaces.

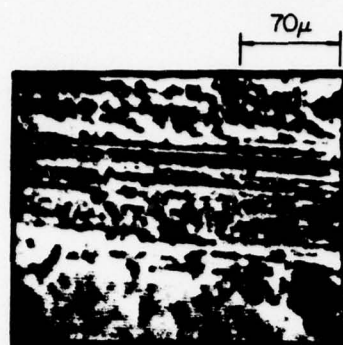
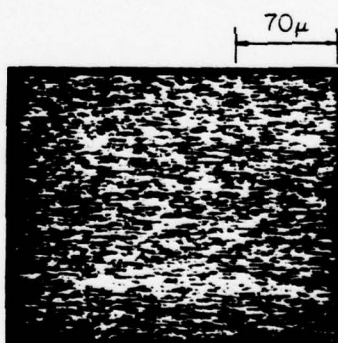
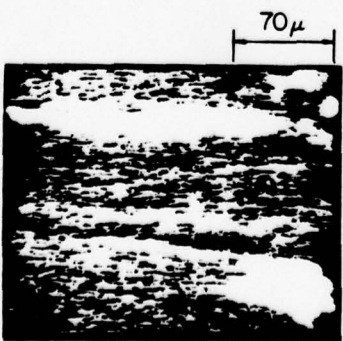
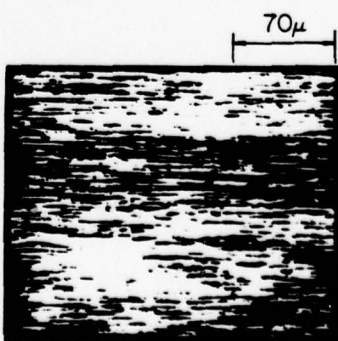
FIGURE 13

To resolve these issues, the surface of the specimen was scratched with a diamond scribe. Panel a of Fig. 13 is an SEM image of the scratch. The surface damage is clearly evident. The virgin-surface AES trace is trace a of Fig. 12. It shows the strong C- and O-signals typical of environmental surface contamination. Also, a strong Cr-signal is now evident, suggesting that the original Cr-coating may have been revealed by the scratch.

These uncertainties are at least partially resolved by the remaining photographs of Fig. 13 which show the Zn-(b), Cr-(c), O-(d), C-(e), Fe-(f), S-(g) and Al-(h) images. The Zn- and O-images still correlate and show strong signals on either side of the scratch face. Concurrently, the Cr-image

Some features of the remaining SAM images also should be noted. First, carbon appears to correlate with Cr, while Al appears to correlate with the ZnO. Sulfur appears in clumps, preferentially at the scratch boundaries. Finally, iron, which is clearly evident in the AES traces (Fig. 12) is very uniformly distributed over the surface as can be seen from the Fe-image, panel f, Fig. 13. (The reason the overall signal level appears low in the Fe-image is that signal contrast is needed over the surface to produce good image contrast). The reason for these characteristics are unclear at present and require further study.

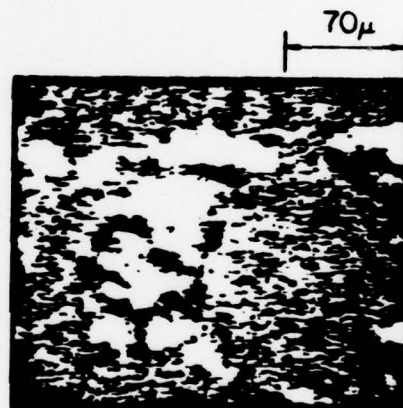
a) Co IMAGE 292 V

b) P- IMAGE 120 V

c) K- IMAGE 251 V

d) S- IMAGE 151 V

e) Al- IMAGE 1390 V

3. SAM analysis of Cr-plated 105 mm bore surface.
